NIST Technical Note 2128

Preliminary Data Collected from the Camp Fire Reconnaissance

December 2020

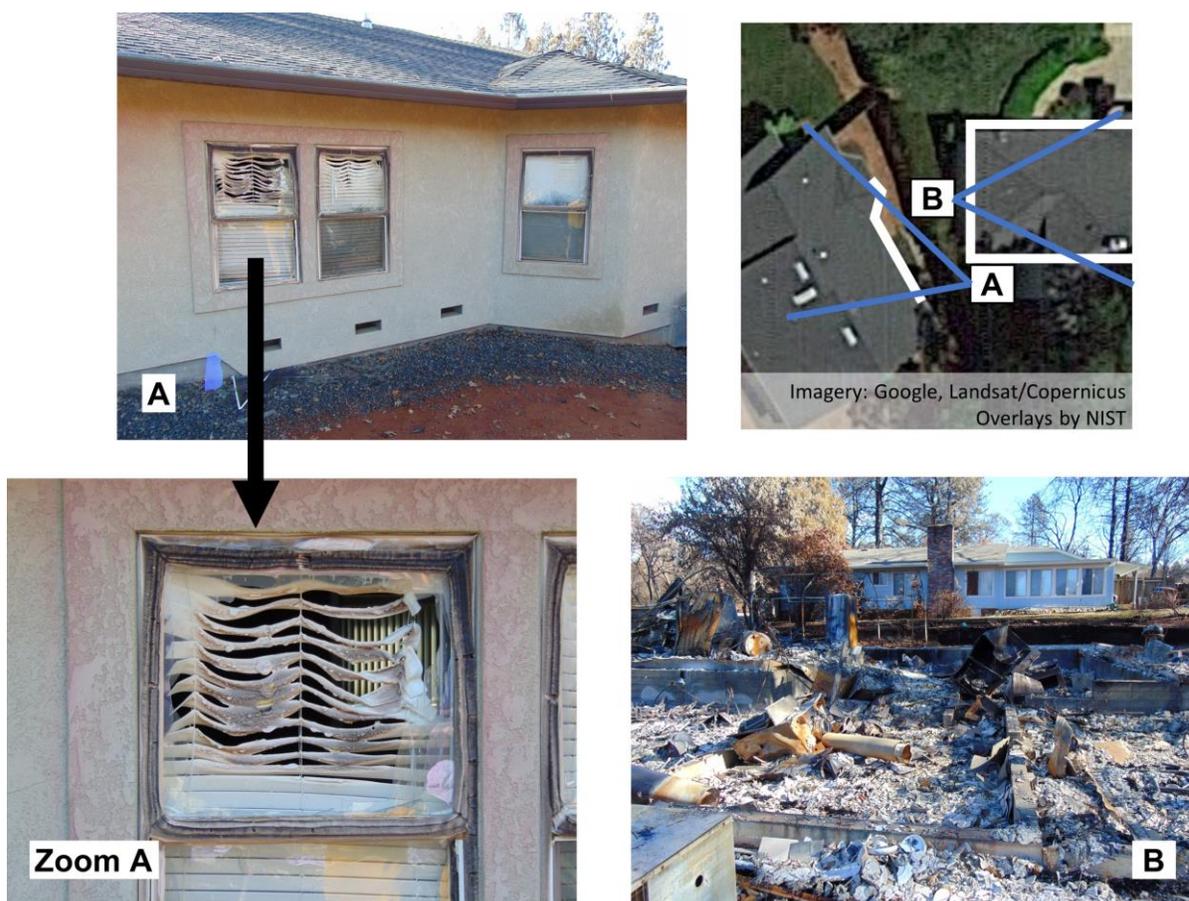
Damage appeared to be due to both direct flame contact and radiation. Significant damage was observed to windows on the “B” side of the structure (left side of structure when viewed from the road/front). Primary exposure sources included multiple burned down fences, both attached and parallel to the structure within 4.5 m (15 ft), as well as a destroyed home 6.4 m (21 ft) away. **Figure 5** shows a photo of the damaged structure along with a closer view of the broken window with significant heat damage to the interior blinds. Additionally, the

Figure 5. View of damage to structure "side B" (image A and Zoom A, left), and destroyed adjacent structure 6.4 m (21 ft) m away (image B, bottom right).

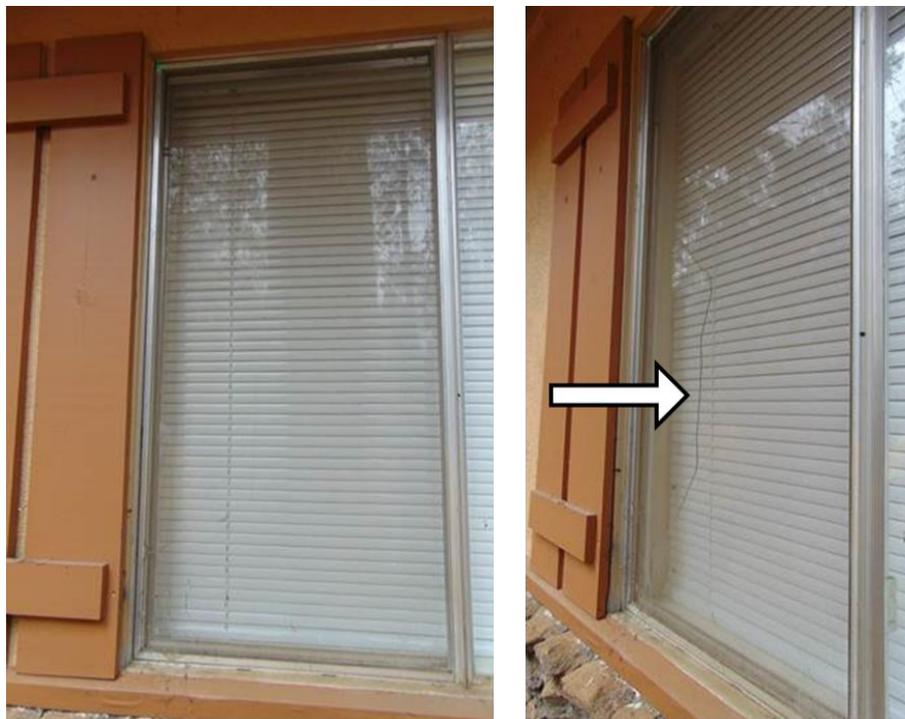
The photos in **Figure 6** show the difficulty of observing cracked windows depending on the viewing angle. The crack is not visible in the left photo; however, it becomes clearer in the right photo when the viewing angle is changed. The optimal viewing angle depends on the crack and may not be the same perspective for all windows.

Figure 6. Cracked window viewed from two different angles.

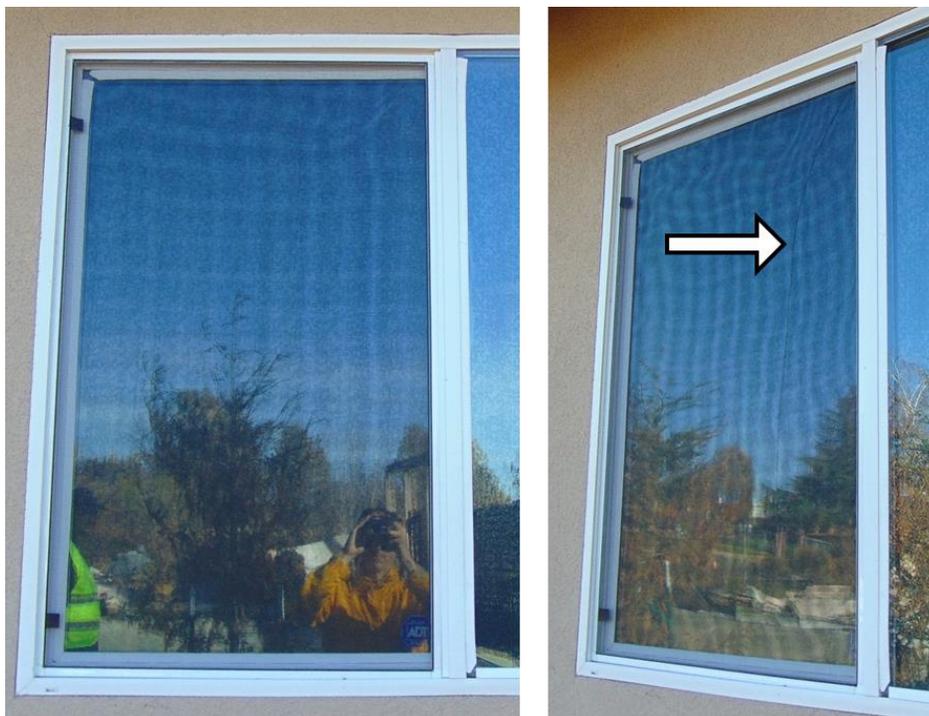
The photos in **Figure 7** show an example of a cracked window behind a screen that is even more difficult to see. The crack is not visible in the left photo. In the right photo, a long vertical crack is visible starting from the upper right corner and continuing down approximately one-third the window width away from the right edge.

Figure 7. Cracked window behind a screen, viewed from two different angles.
