NIST Technical Note 2128

Preliminary Data Collected from the Camp Fire Reconnaissance

December 2020

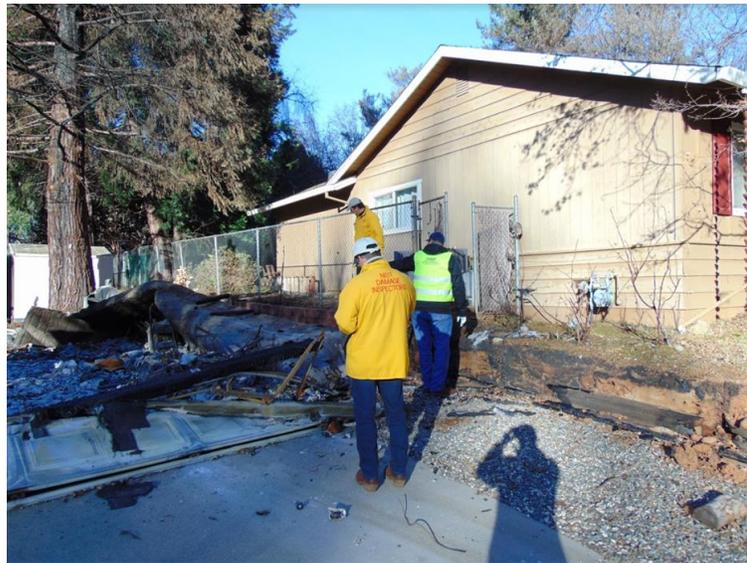
Figure 3. Camp Fire NIST Field Data Collection.

During the NIST data collection efforts in the field between December 1 and December 12, 2018, a total of 132 damaged residential structures were assessed. Each assessment consisted of a three- or four-person team performing a walk-around to identify any damage (**Figure 3**). If damage was found, a Damage Assessment Report (Appendix A) was completed to record the type of damage and other details about the structure characteristics. Photos were taken to document the damage.
